# TEAM VEOLIA IMPROVES DAIRY UTILITIES

CASE STUDY | Food & Beverage

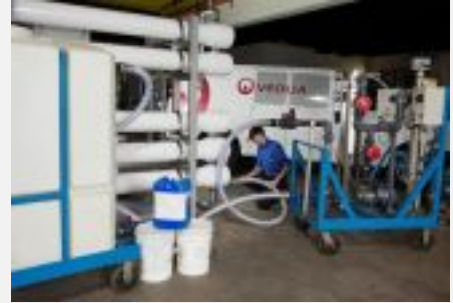
Veolia Team Service performing a Membrane Cleaning on an RO

- Veolia's Team Service began to improve make-up water quality by rebuilding the water softeners and establishing a Preventative Maintenance program for the plant's Reverse Osmosis unit, Filters and Softeners.
- The Boiler and Cooling water systems were automated with Veolia controllers and drumless Hydrex™ feed & storage systems were added.
- Veolia's Hydrex™ Boiler and Cooling water treatment chemistries were introduced, along with more frequent service and Key Performance Indicators (KPIs) established.
- Daily testing protocols were upgraded, and Veolia's cloud based data management software (Veolia VisionNA) was instituted for proactive water management & control.

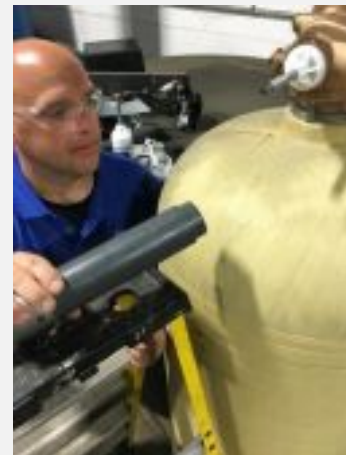
Veolia Team Service performing a Membrane Cleaning on an RO

- Make-up water quality has improved substantially due to the Softener rebuild, removing hardness more effectively and consistently.
- The Reverse Osmosis unit is operating more efficiently, with output increasing back to within original design flow rate specification.
- Cooling water system corrosion rates are all now < 1 MPY on Mild Steel and < 0.5 MPY on Copper. (Below Right). The Bacterial slimes that were prevalent in the systems are also now under control.
- Boiler inspection has revealed the removal of old iron deposits and re establishment of a gun-black magnetite iron surface. (Below left)
- Plant Maintenance has reduced their number of water related vendors from 3 to 1 with the Veolia team, and they now focus more of their time on production related issues.
